COMMONWEALTH OF KENTUCKY
BEFORE THE PUBLIC SERVICE COMMISSION

SHOW CAUSE ORDER

ELECTRICAL UTILITY ACCIDENT INVESTIGATION

INVESTIGATION OF AN ACCIDENT IN
BIG RIVERS ELECTRIC CORPORATION, COLEMAN PLANT

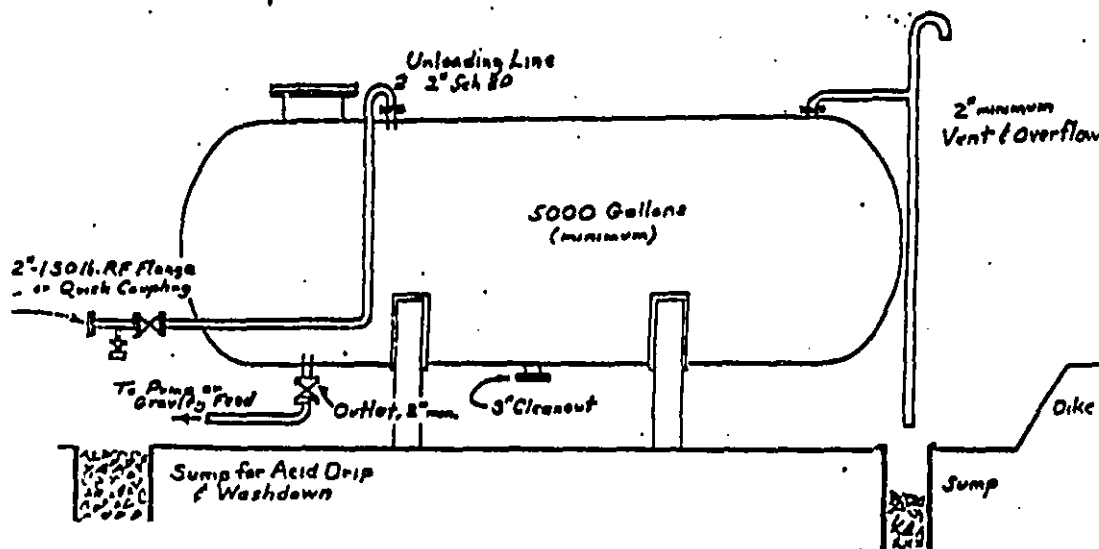
Figure 1

The tank was constructed with a vent. The purpose of the vent connection is to release the vapor mixture from the top of the tank. An overflow line is used to drain the excess acid in case of overloading the tank. The overflow line and the vent line may jointly be connected to the vent nozzle as shown in Figure 1, page 6.

4. A vent and overflow is shown in a typical tank's drawing as shown in Figure 1.

Typical Sulfuric Acid Storage Tank Arrangement

Tank 1 was not appropriately vented. There was no vent line connected to the outside of the tank's vicinity. The 2-inch overflow line, which was found broken, was inappropriately considered a vent line. The overflow line is used in case acid Tank 1 is overfilled during loading. A vent is recommended for a sulfuric acid tank because of formation of hydrogen gas in the vapor phase. Since hydrogen and air make an explosive mixture (4 to 74.2 volume percent hydrogen), it is essential to connect a tank vent to a point outside the basement and preferably with a flame trap and/or a desiccant dryer. If the tank was idle for most of the days, the condition would be even more hazardous.

1. The tank wall thickness should be tested periodically by UT; and if corrosion is observed and material thickness becomes below the recommended level, the tank should be repaired promptly or replaced.
2. A proper vent should be installed on the tank to release the hydrogen into a safe area outside the vicinity of the tank.
3. Any cutting or welding in the tank's area should be forbidden unless the tank is blinded and completely isolated and the area is tested to be explosive free. Proper safety instructions should be displayed on the permit and on the tank.
